Continuous Analog Troubleshooting Guide

For the Plexon MAP System

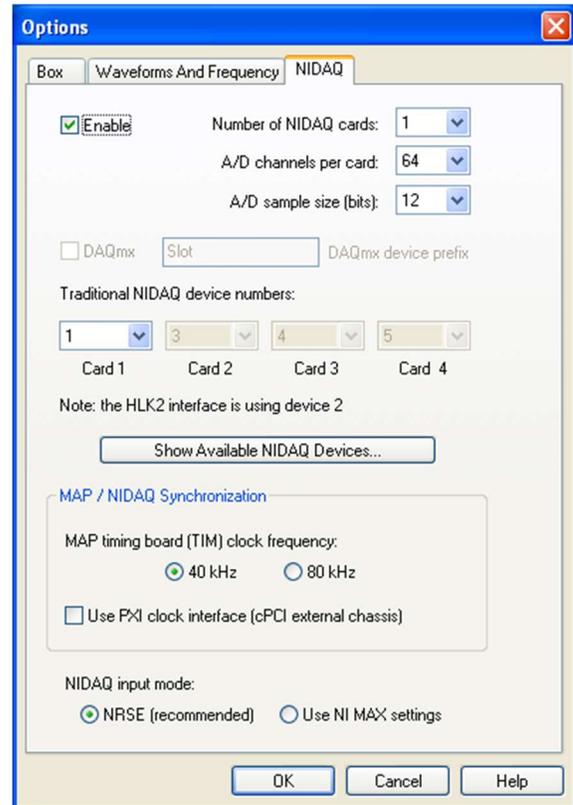
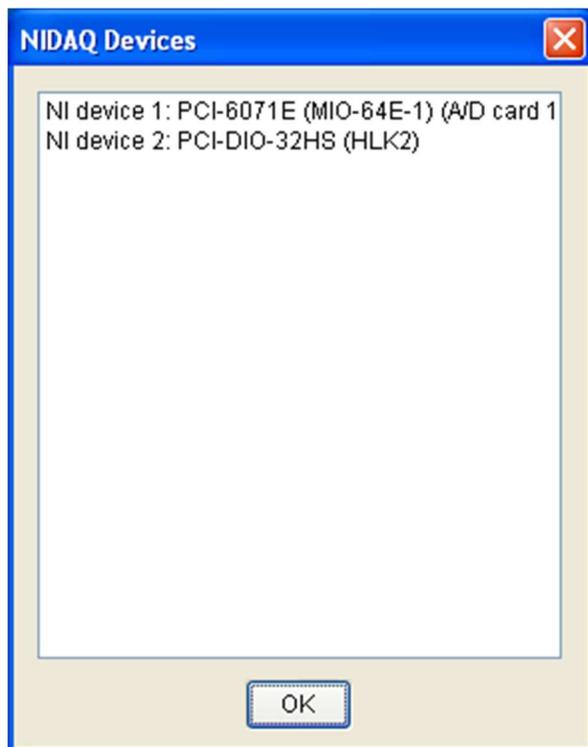
This is a straightforward process of matching device numbers listed in NIMAX (under the Traditional NIDAQ Devices header) with the devices listed in the NIDAQ tab of the Server options.

RASPUTIN 2.6.0 and later has a button in the NIDAQ tab called “Show NIDAQ Devices” that should prevent the extra step of opening NIMAX to view the devices.

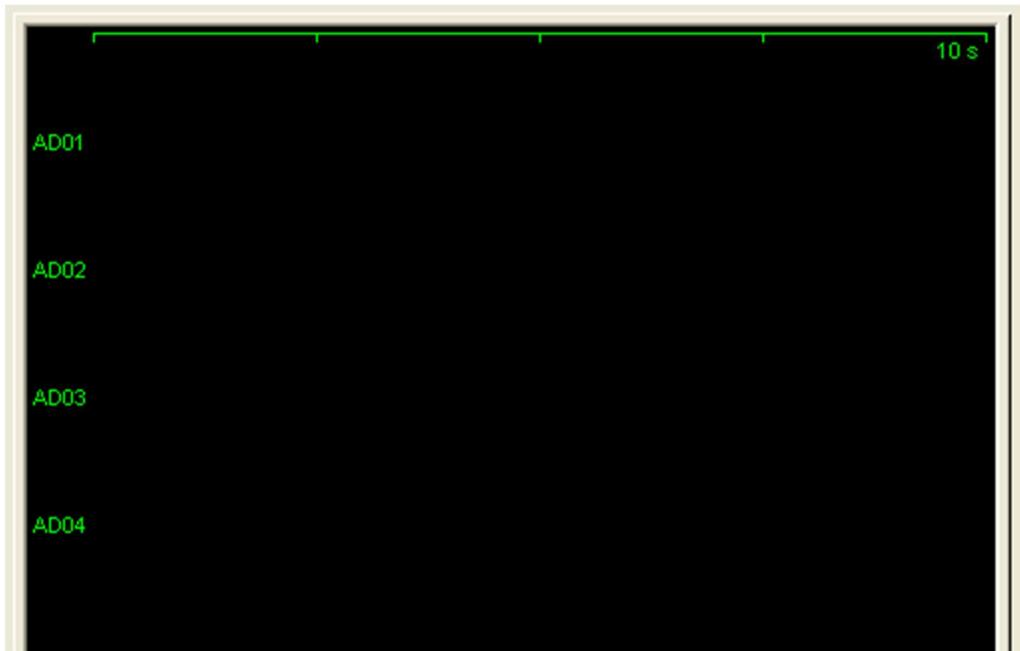
If you can see the channel names for your analog signals in the Activity Display but don't see traces sweeping from left to right then your A/D system is not receiving timing information. The “zero line” can sometimes hide the trace (if it's at zero) so it's helpful to turn it off (right click menu).

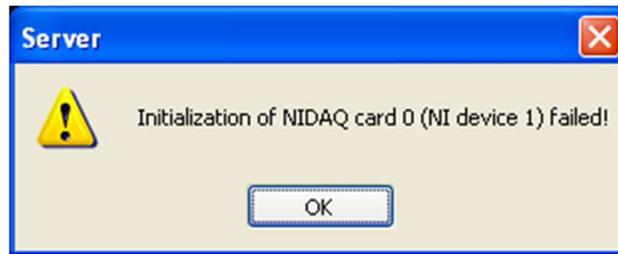
Server will pop up an error message with a description of which NIDAQ card it attempted to initialize but failed.

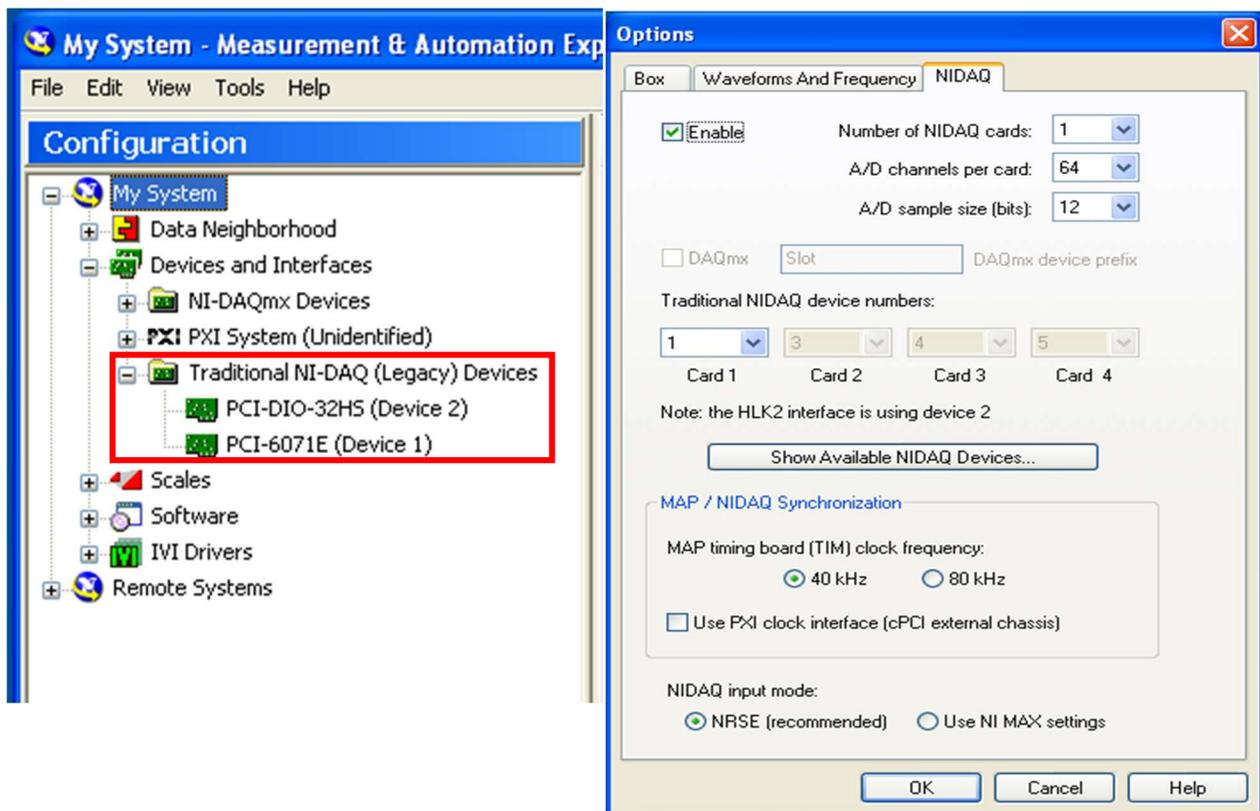
This error is most commonly caused by having a device number set incorrectly in Server. Check the A/D board device numbers in NIMAX or the NIDAQ device viewer in Server and match the settings in Server.

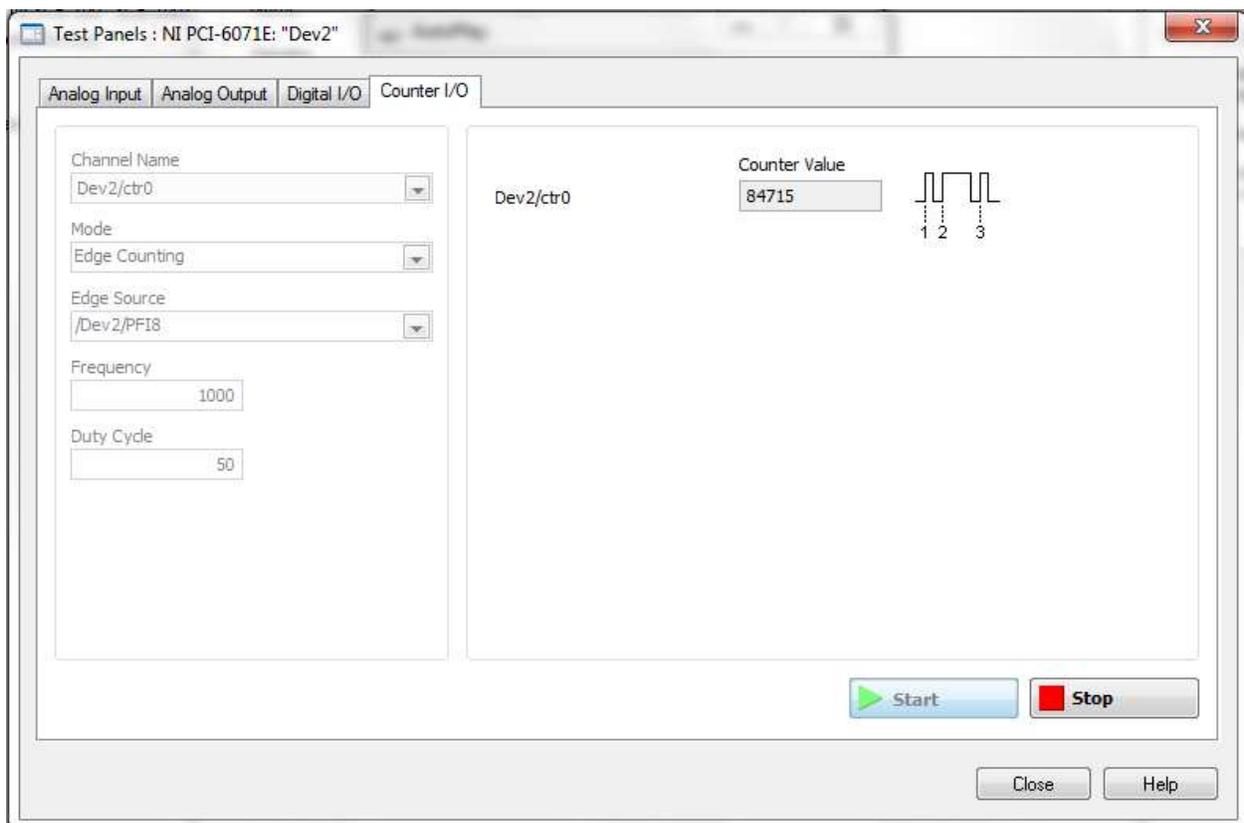
First check that the clock signal from the MAP TIM board is being received by doing the following.

Under “Channel Name” select “Dev2/ctr0”.

Under “Mode” select “Edge Counting”

Under “Edge Source” select “Dev2/PFI8”

Click the “Start” button in the Test Panel window. The “Counter Value” should begin to quickly increase in value. This verifies that the clock signal is being received.

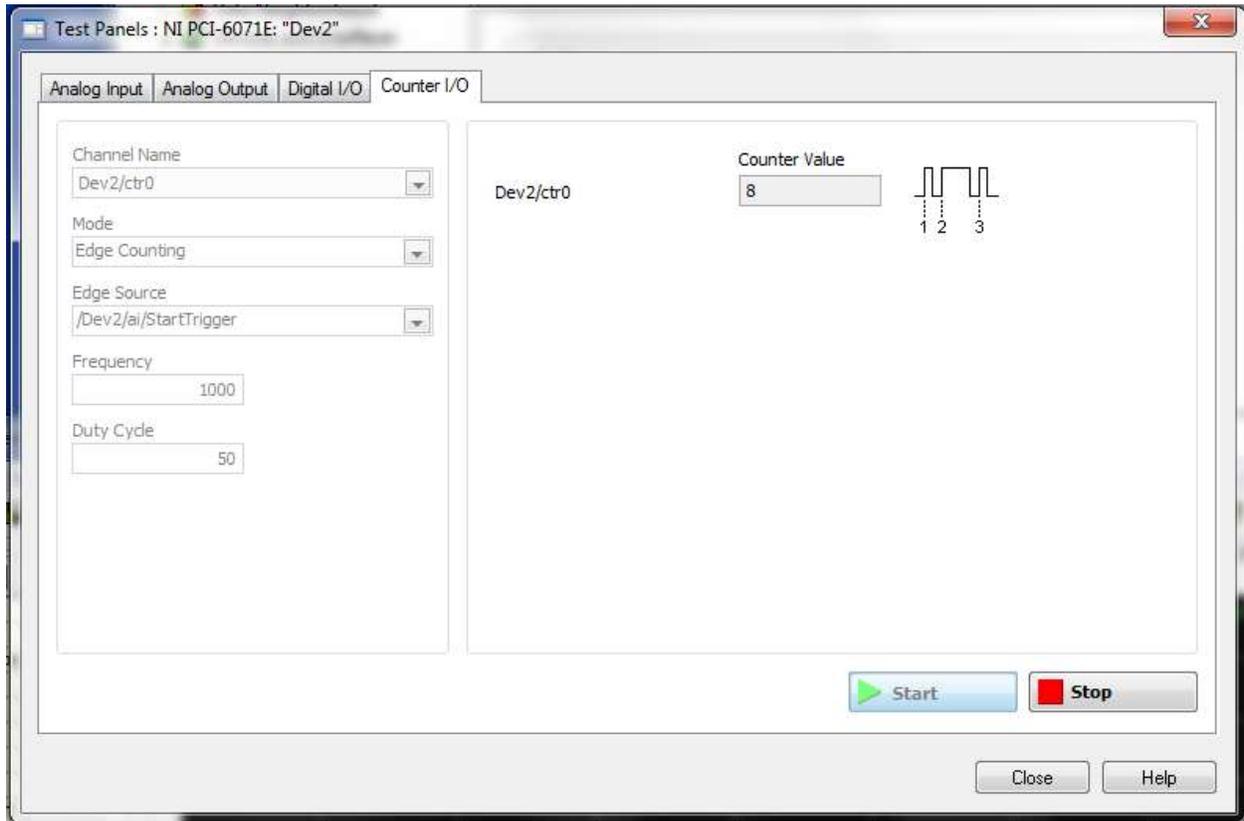
Next check that the “Update Server” signal from the MAP TIM board is being received.

Under “Edge Source” select “/Dev2/ai/StartTrigger”.

Click the “Start” button in the Test Panel window. In the MAP SortClient, enable some analog channels and click on “Update Server”. The “Counter Value” should increase by 1 every time you click on “Update Server”. Click on it several times to make sure you

can consistently increase the counter value every time it is clicked. This verifies that the Update Server signal is being received.

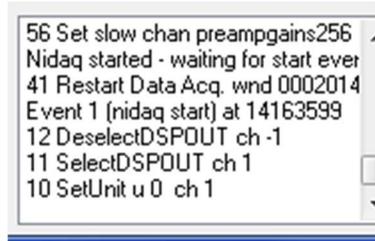
When clicking "Update Server", the MAP Server message window should show a message that says "Nidaq started – waiting for start event" followed by "Event 1 (nidaq start) at". The latter message should include a value that represents the number of clock pulses received by the NI board up to that point.

Subsequent clicks of "Update Server" should show that value increase (since the clock should always be incrementing).

If this is not being displayed in the Server message window, the clock or start signals might not be successfully transmitting from the MAP TIM board to the NI A/D board.
